The little round house on Wheatlands Lane

Ann Hall

25 July 2019 annhall4@hotmail.com

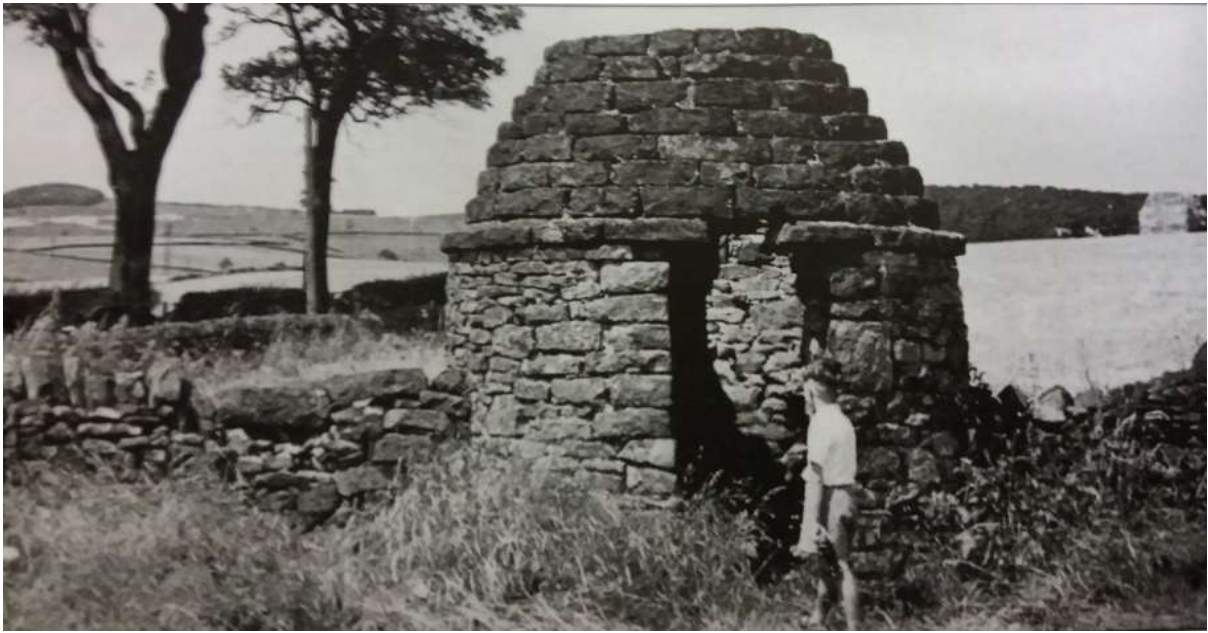
An old photograph from the first half of the 1900s shows that the building had seven full courses of stone with the upper layers missing providing evidence for deterioration.

The roof is incomplete as shown in a photograph from the first part of the 1900s. By 1977 it had lost another course of stone completely and three stones are missing from the next lower course. This suggests that the integrity of the roof corbelling is at risk.

Unknown date (first part of 1900s?) showing the roof with seven courses of stone and with keystone absent and showing field walls on either side. Frank Rodgers. (N.B. I have been unable to contact the photographer to ask for permission to use this photograph or to establish a more definite date.)

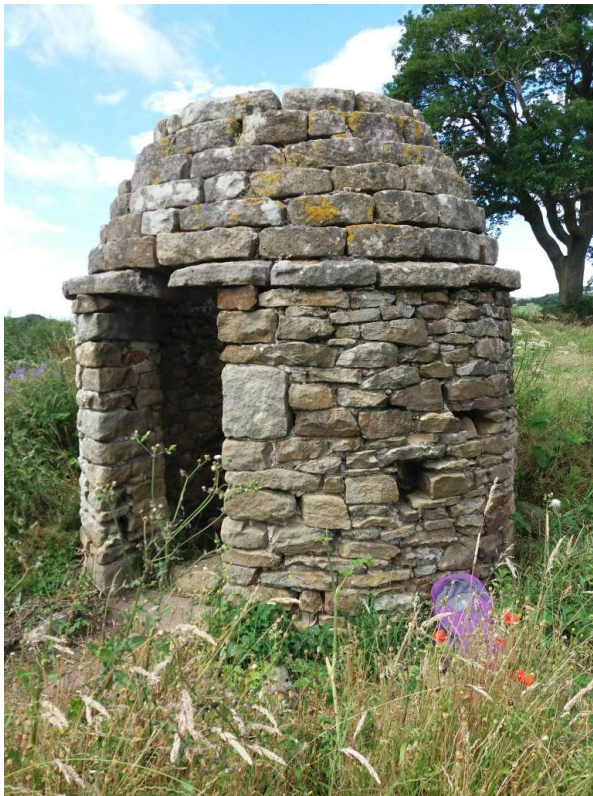
There are four areas in the wall where stone has been lost. Two openings to the north vary between 0.20 and 0.35 m each through both layers. They appear to have a lintel on the inner side but not on the outer side suggesting that these may have been niches within the building, which have weakened the wall and have allowed deterioration of the outer face in these areas. The lintel stones are not robust and may be fortuitous, meaning that the openings result solely from deterioration in both sides of the wall. A third area of stone loss through both the outer and inner layers to the north of the building is smaller approximately 0.20 x 0.25 m and has no lintel stone. A fourth area to the south is 0.30 x 0.40 m and only present in the outer layer. These last two areas were not described during a survey in 1999-2000 suggesting that the wall condition is gradually deteriorating.

Loss of stone from the walls has occurred in four places. Two of these were present by 1999 and two more are now evident.

From the north east showing two areas of wall loss and the stone sill of the doorway.

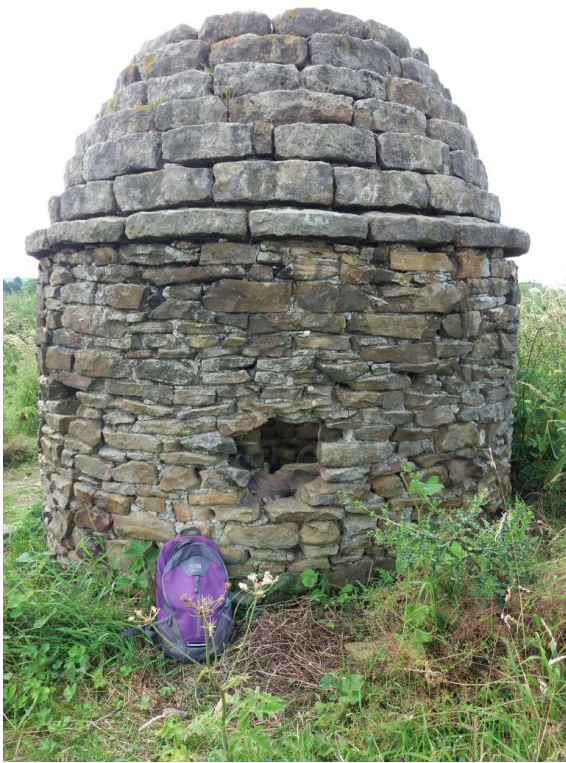
From the north. Showing another area of wall loss. (Rucksack for scale)

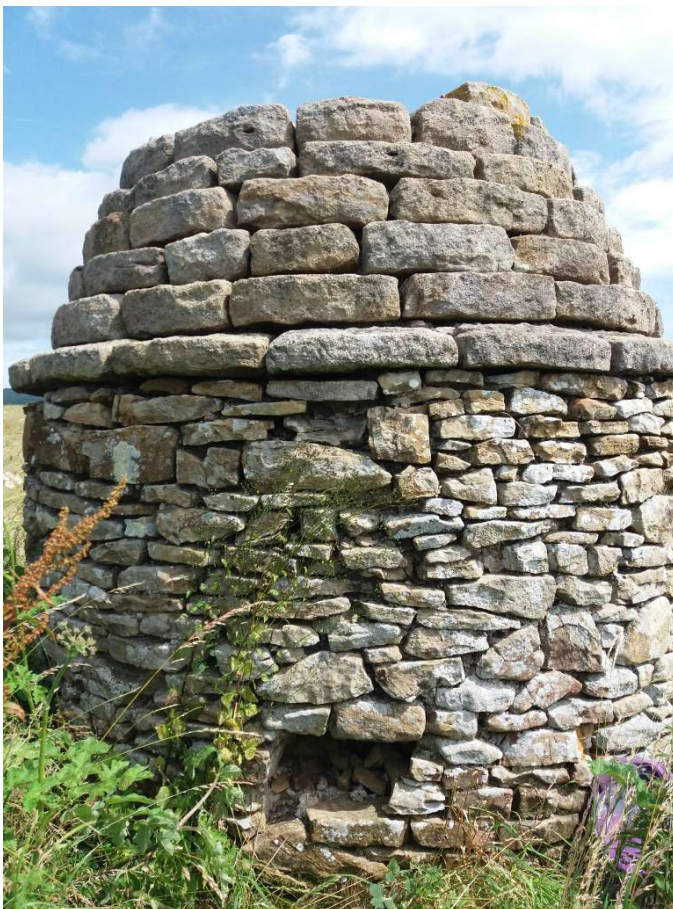
From the south showing wall loss in the outer layer only.

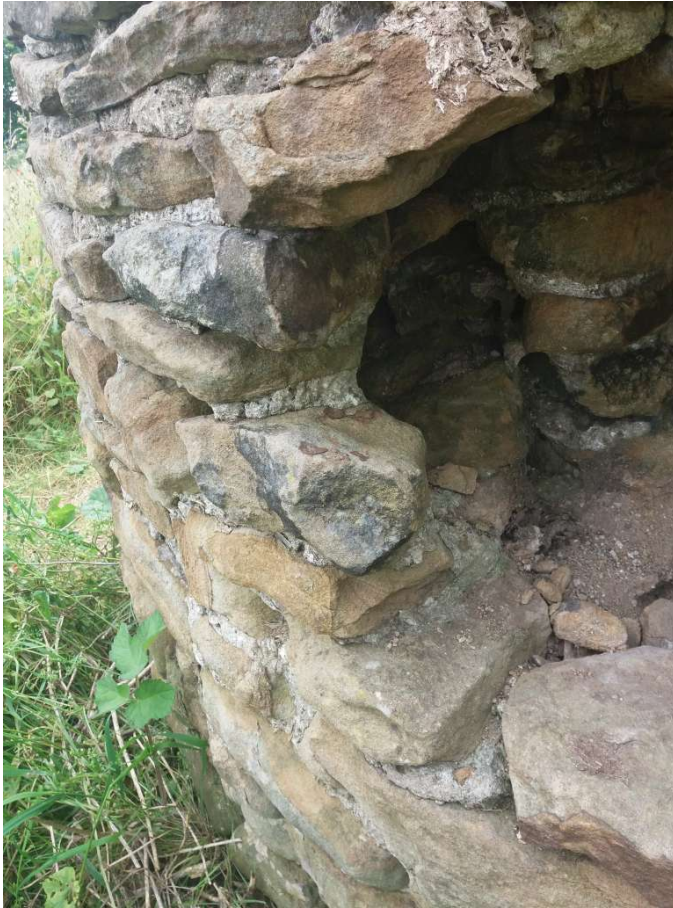
The walls are between 0.45 and 0.55m thick and are made of a mixture of sandstone in a similar manner to a dry stone wall, having an outer and inner layer filled with rubble. However the stones are held together with limestone mortar both inside and out, much of which has deteriorated. Internally in some places the mortar has been heavily applied suggesting a previous use which required some weather proofing. However it may be that the lime mortar is not part of the original structure and has been used at a later date during its repair.

At some time in the past the building has been extensively pointed with lime mortar. This may have helped to explain its longevity. However this mortar has been lost in many places throughout the roof and walls leading to openings between the stones.

From the north east, showing the wall made of an outer and inner layer of sandstone and rubble fill, with lime mortaring
