The little round house on Wheatlands Lane

Ann Hall

25 July 2019 annhall4@hotmail.com

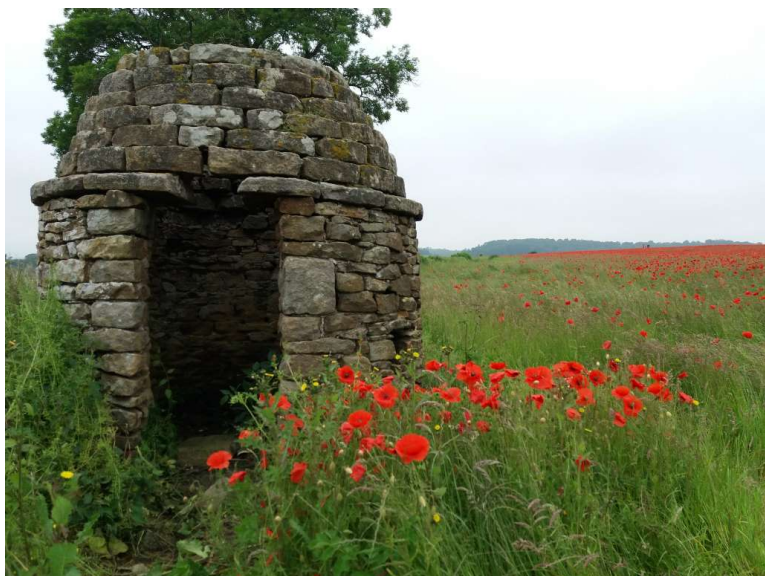
An old photograph from the first half of the 1900s shows that the building had seven full courses of stone with the upper layers missing providing evidence for deterioration.

The roof is incomplete as shown in a photograph from the first part of the 1900s. By 1977 it had lost another course of stone completely and three stones are missing from the next lower course. This suggests that the integrity of the roof corbelling is at risk.

Unknown date (first part of 1900s?) showing the roof with seven courses of stone and with keystone absent and showing field walls on either side. Frank Rodgers. (N.B. I have been unable to contact the photographer to ask for permission to use this photograph or to establish a more definite date.)
